**Re: Redondo Beach Energy Center Project (12-AFC-03)
Data Adequacy Supplement**

RE: Redondo Beach Energy Project (12-AFC-03) Data Adequacy Supplement

Application for Certification

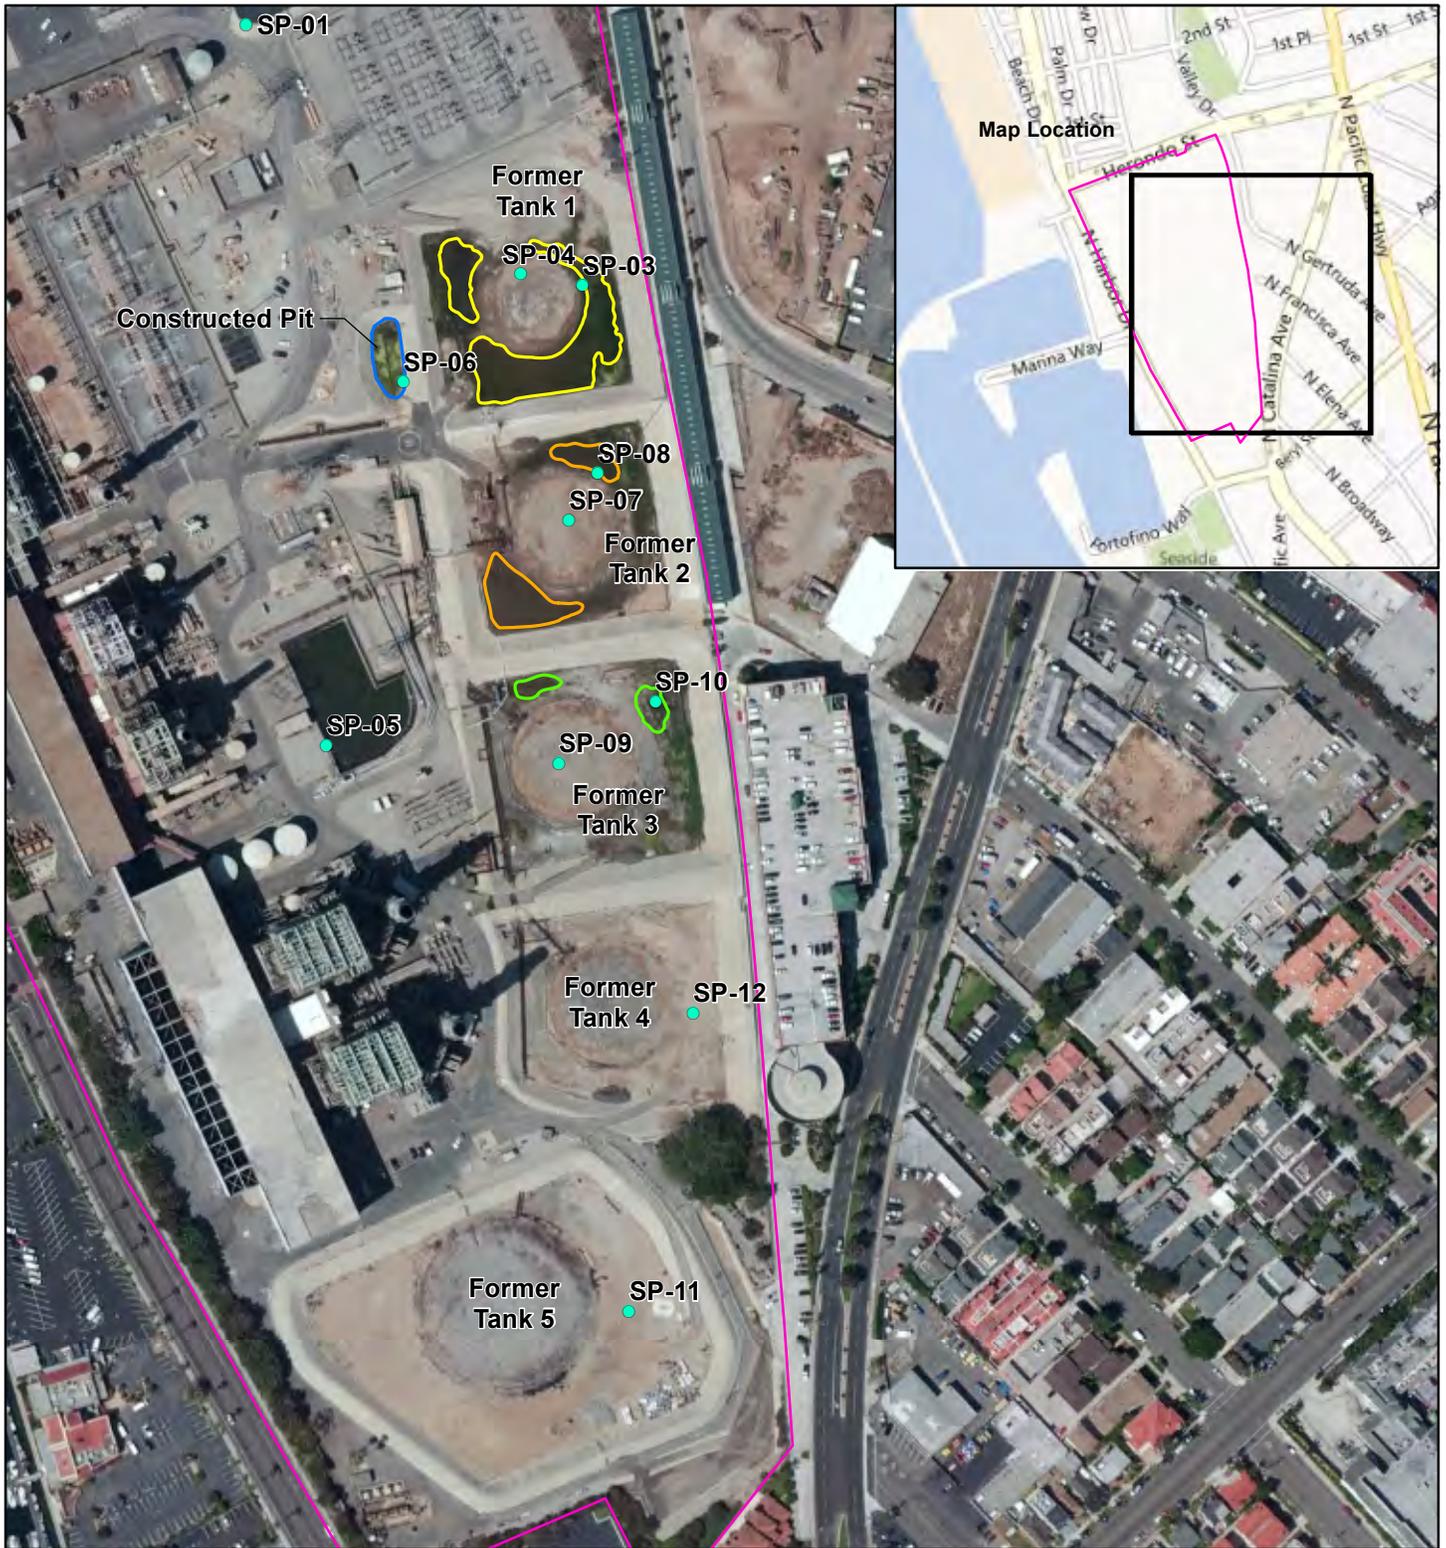
- Wetland Delineation - Sample Locations
- Constructed Pit - 0.08 Acres
- Former Tank 1 - 0.431 Acres
- Former Tank 2 - 0.202 Acres
- Former Tank 3 - 0.066 Acres

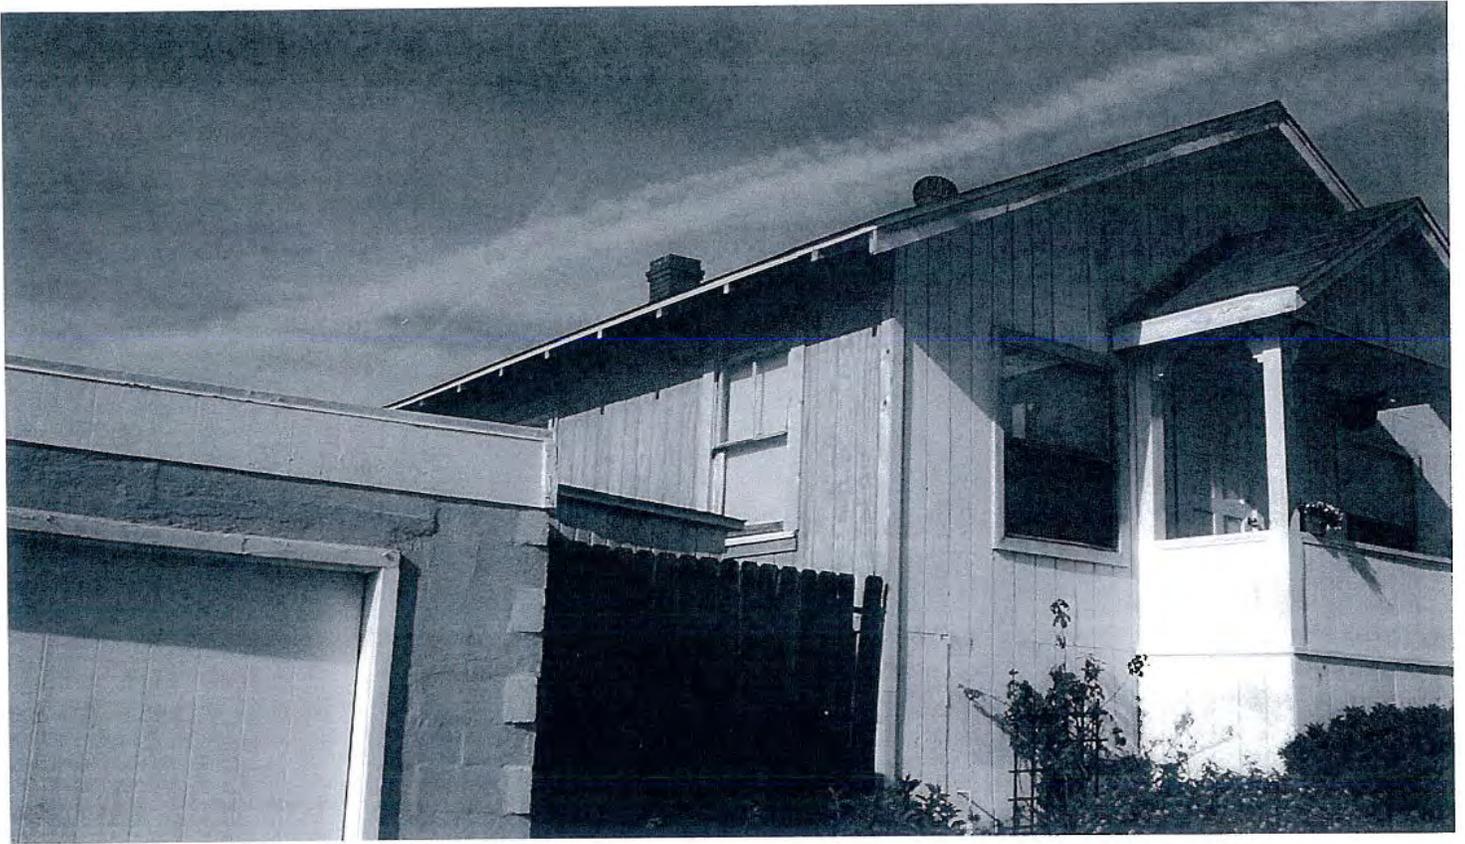
View of New Siding on South Elevation, 625 Diamond Street (WNW).

This is a single-story house with a medium gable roof. The original siding was removed and replaced with sheets of vertical wood siding and, during a restoration attempt, the porch roof fell off. The original garage was detached, now the replacement garage is attached to the east side of the house. So, although this house is an older building, it has been significantly altered. However, the original windows, frames, size, and shape of the house has not changed, so it is compatible with the neighborhood. The garage was built in 1971, and the siding of the house was replaced at the same time.

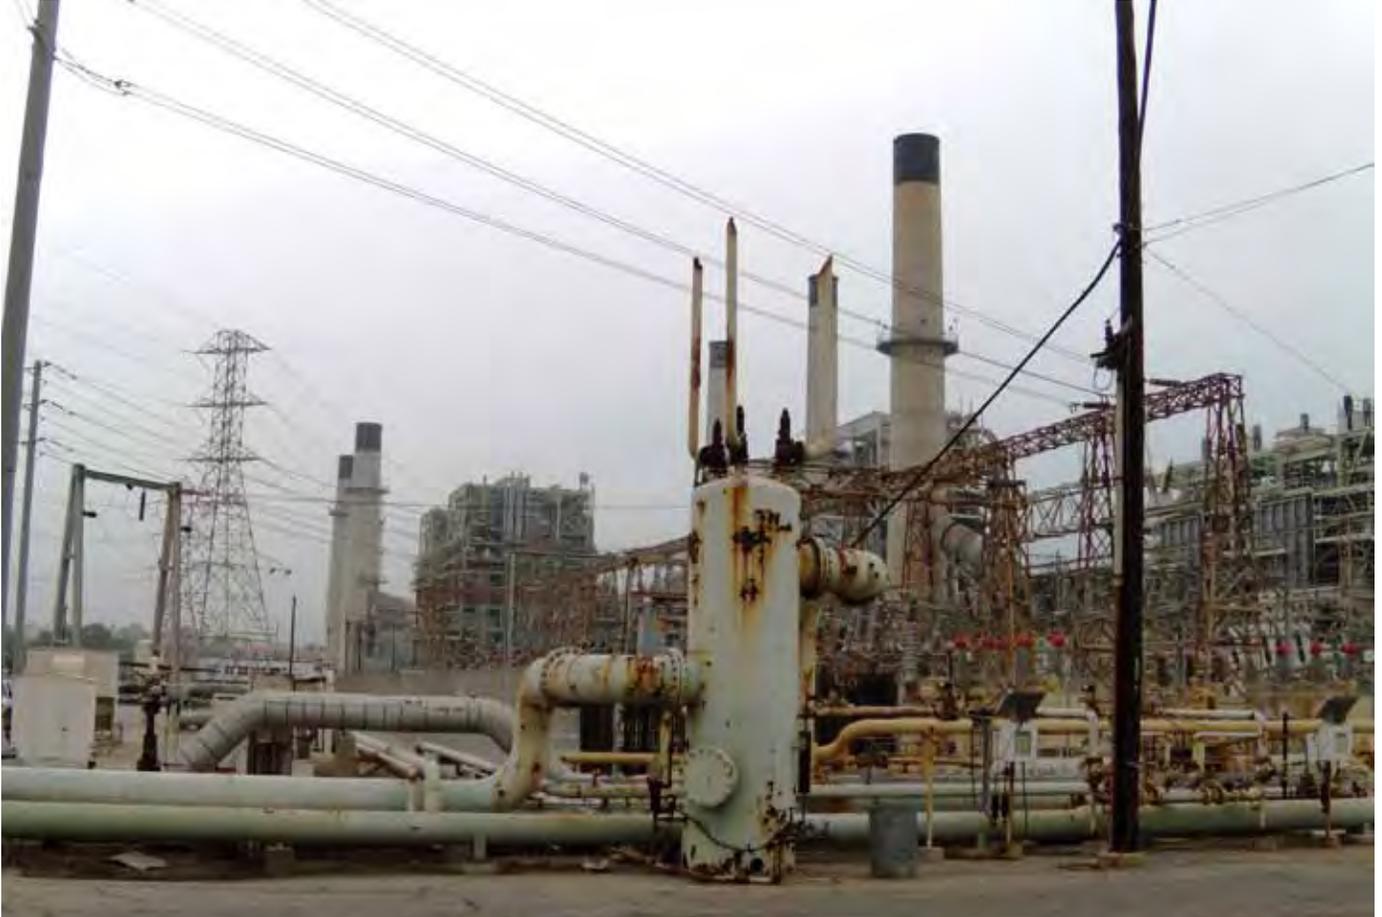
Plant overview looking south; gas service in foreground. Showing all five remaining exhaust stacks.

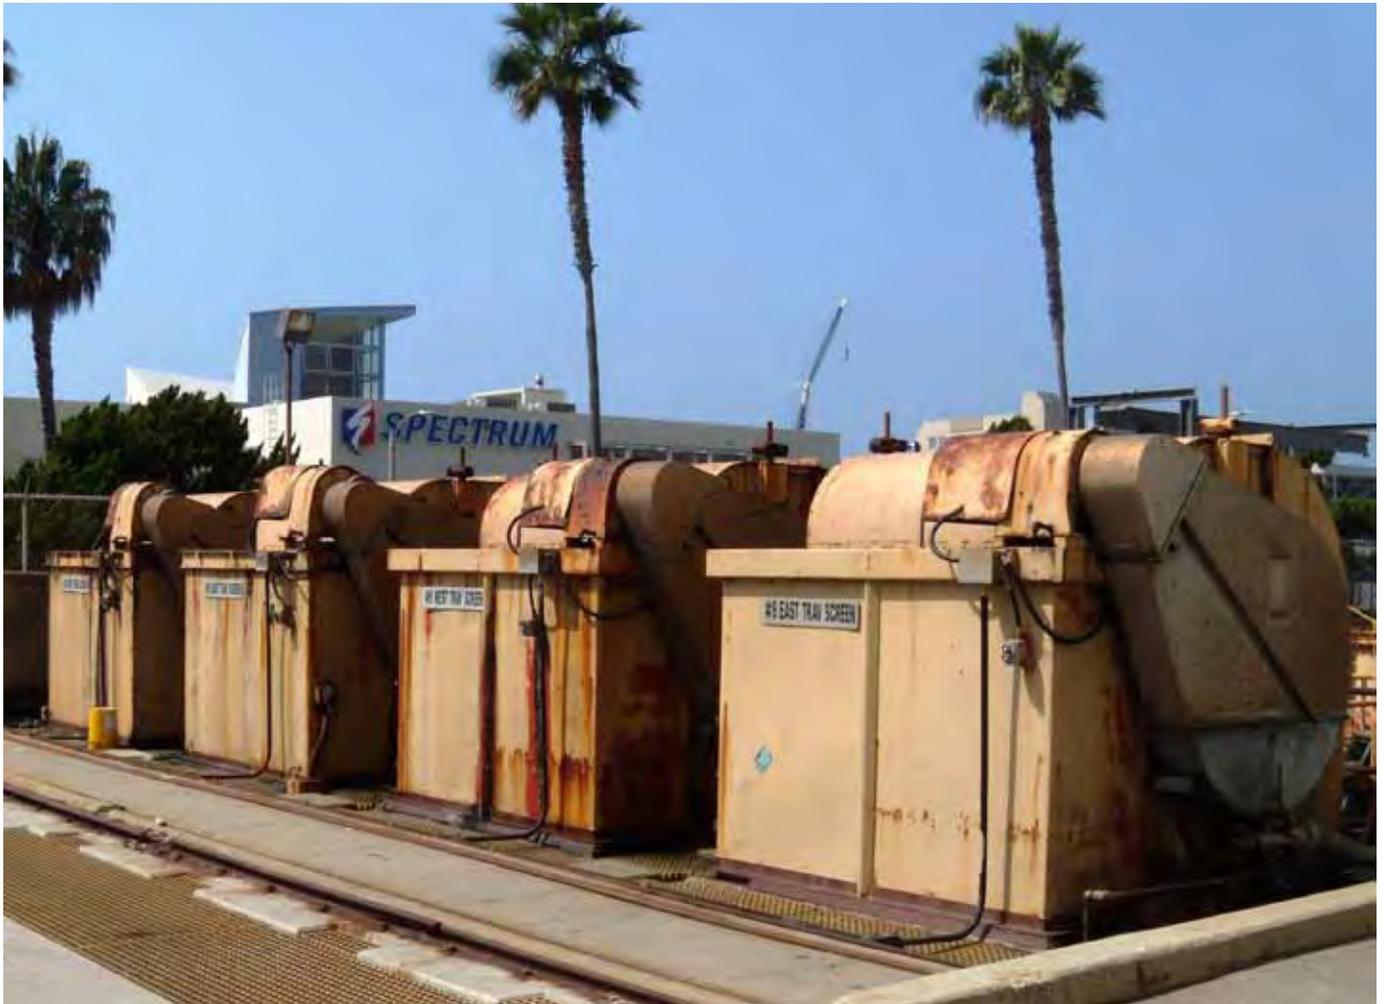
Water entering the intake structure passes through trash racks to remove large debris. The trash racks are located downstream of the main stop gate. Each trash rack consists of a series of vertical bars spaced to provide 3-inch openings. The traveling screens are located downstream of the trash racks. Traveling screens are provided for each pair of units. Channels are provided per unit pair with each channel housing an individual screen. The screens are constructed of stainless steel mesh with 5/8 inch openings. Motor operated hoists and support structures are provided to raise and lower the screens during washing operations. The screens are washed with a spray of salt water as they travel through their cycle. Debris is washed into a trough and then to a screen belt. The debris is discharged into a trash basket and is ultimately disposed of. Two circulating water pumps are provided for each unit.

Plant 2 traveling screens, view looking NW.

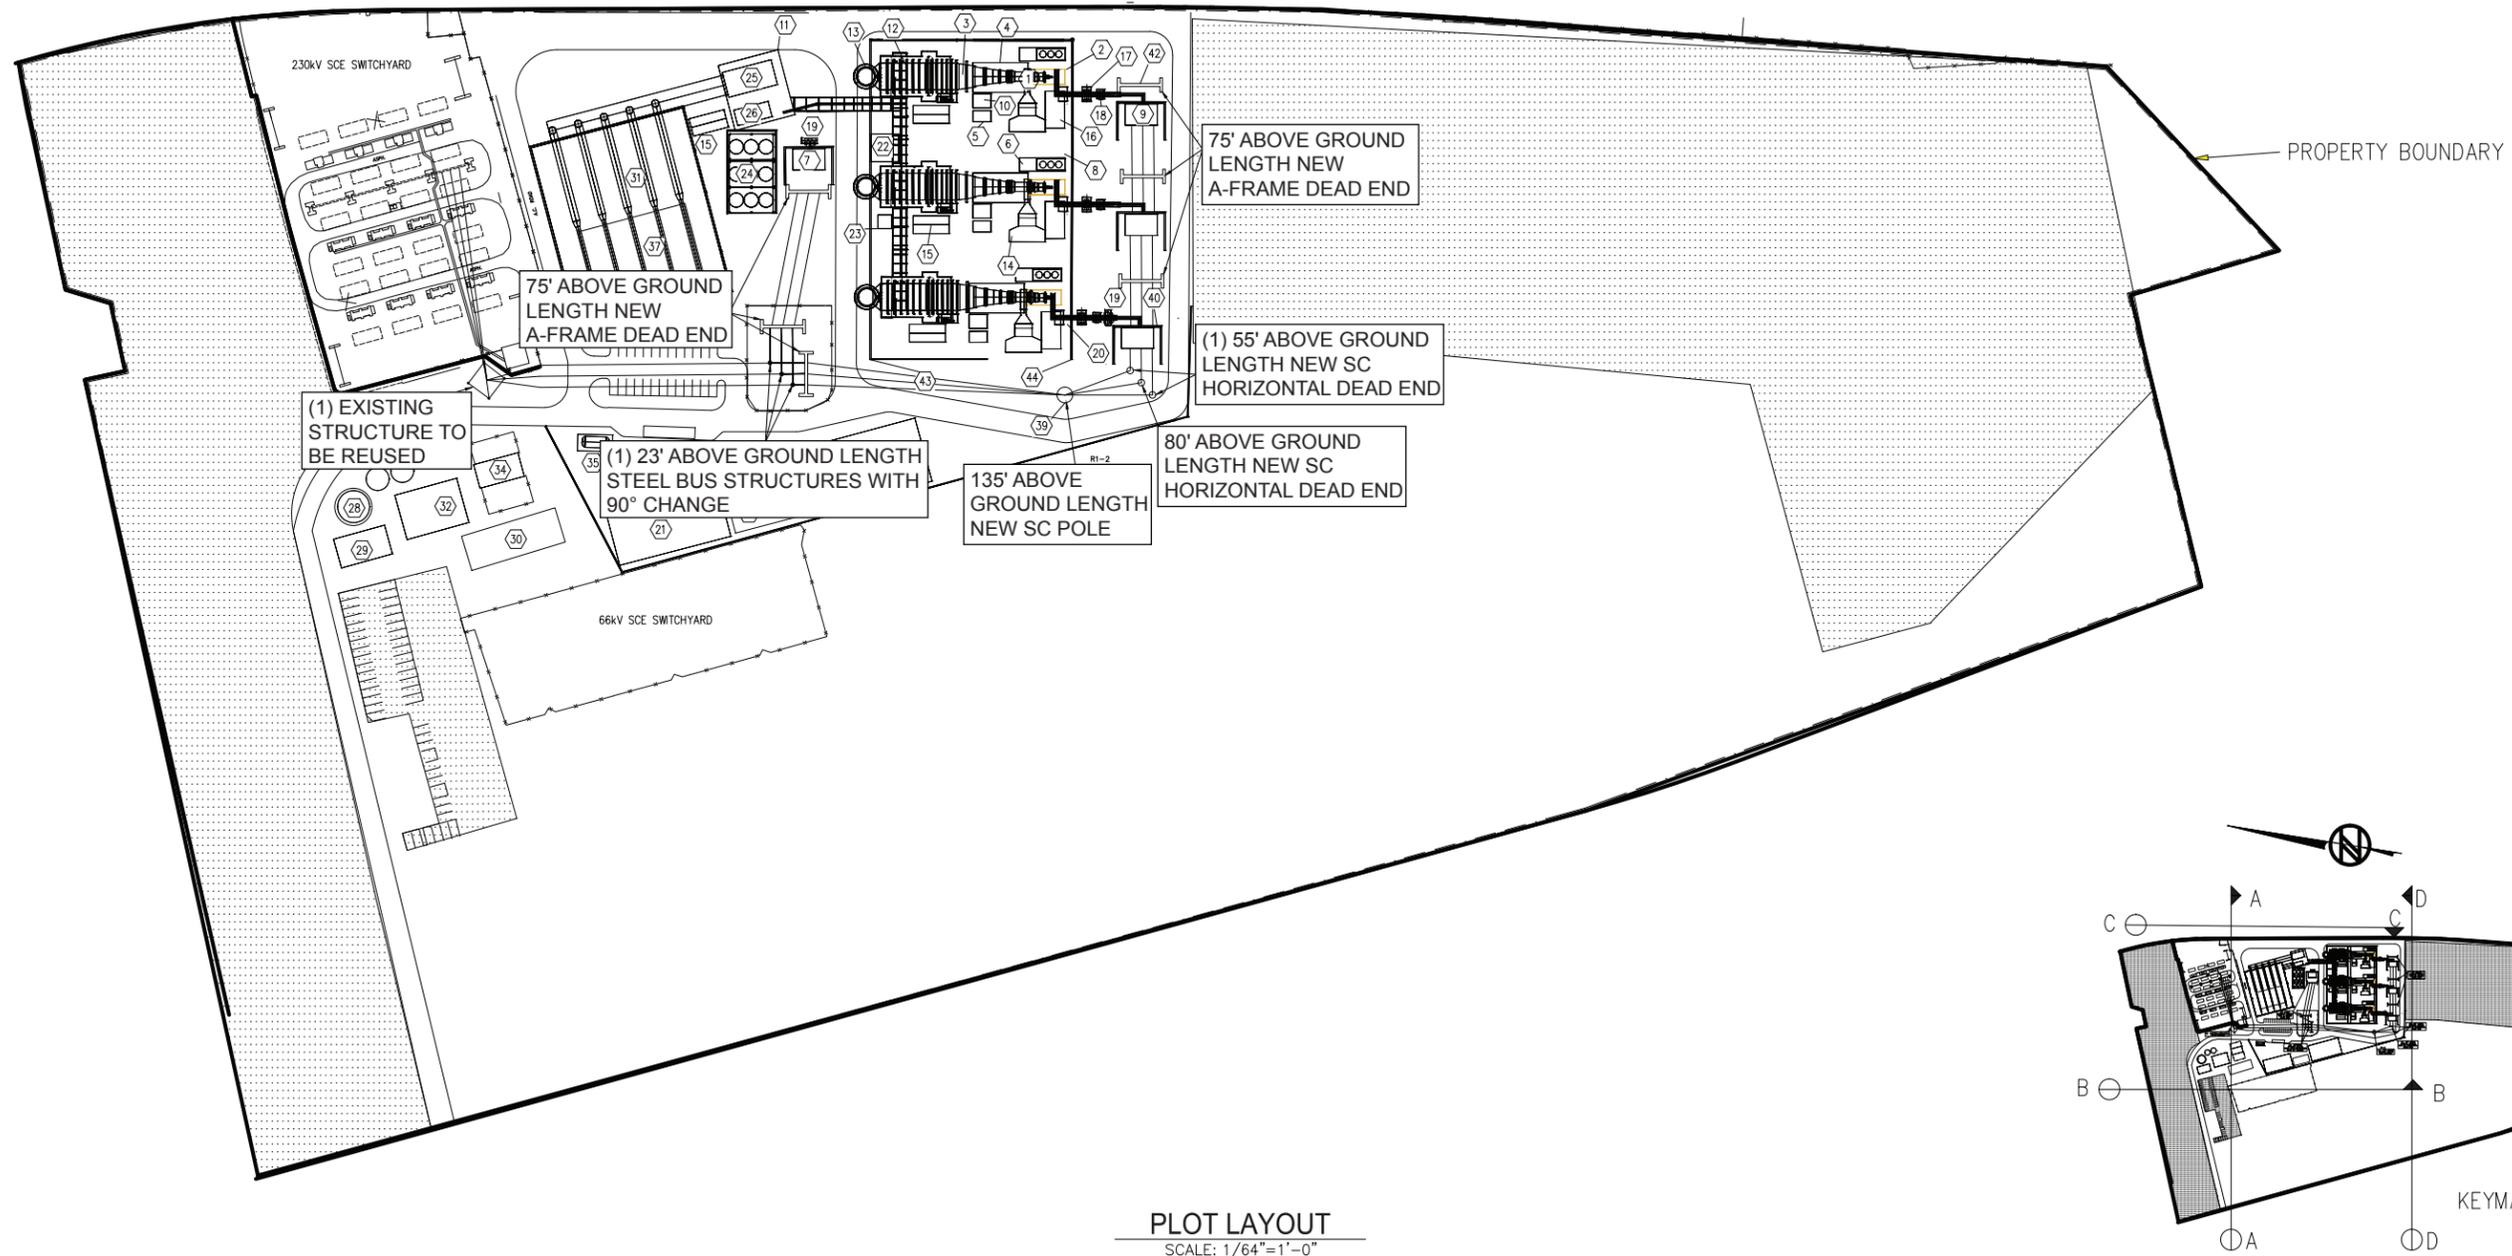
PLOT LAYOUT
 SCALE: 1/64"=1'-0"

— FENCE
 [Hatched Area] CONSTRUCTION PARKING AND LAYDOWN
